SOCIO-ECONOMIC STUDY - Trzęsacz (Poland)

MESSINA PROJECT COMPONENT 3 : VALUATION OF THE SHORELINE

Case study made within the Messina project, Component 3.

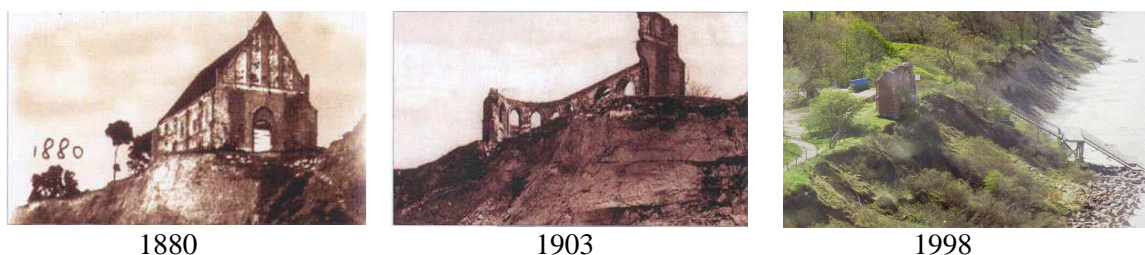
Fig 1. Ruins of XIII century church in Trzesacz.

Trzesacz it is a small village at the seaside belong to Rewal Community. The village has coast almost one km long, but developed area at present time is about 400 m long. The area is located at the top of 14 m high Pleistocene cliff. Parcels are located about 30-50 m form the range of the cliff. Just at the range of cliff there are located ruins of the XIII century Gothic church (Fig.1).

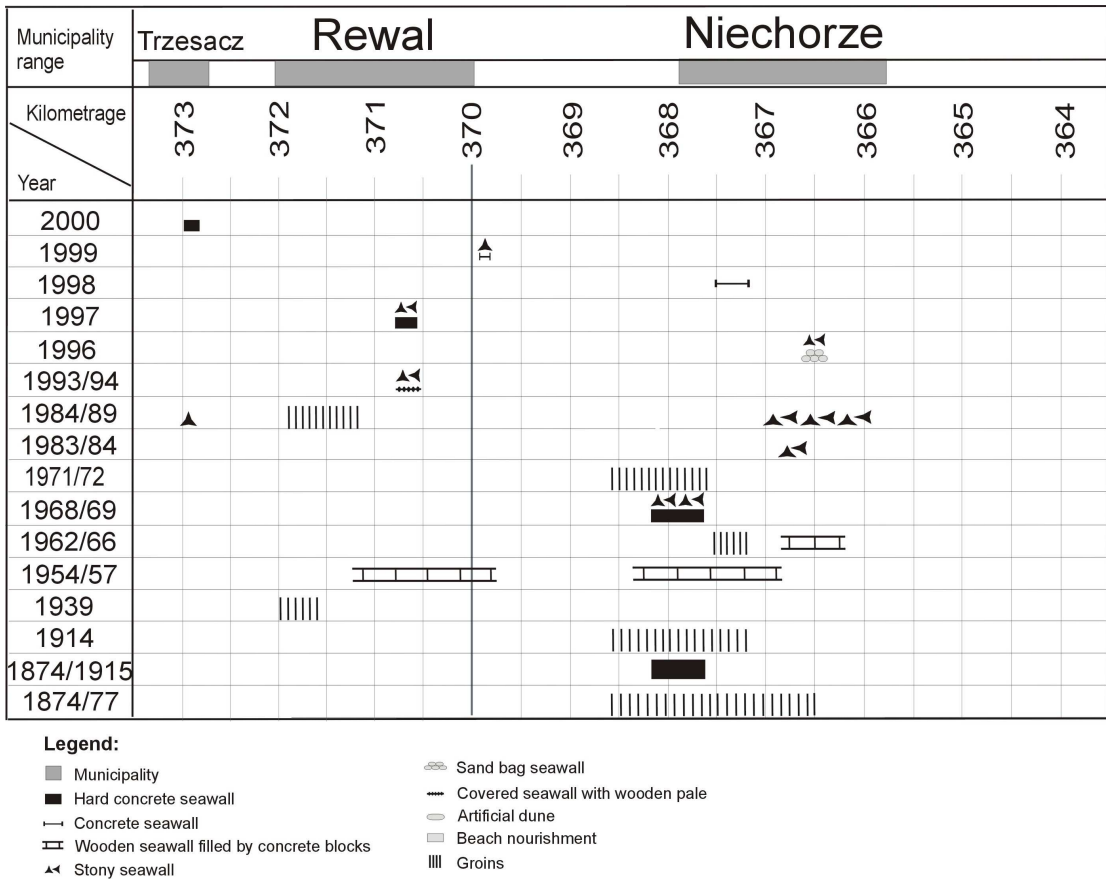
Fig.5. Methods of coastal protection at the study area.

Various methods of coastal protection were used at this area. Their location and construction periods are presented at diagram on the Fig. 5.

Effectiveness of the protection is very various. The most effective methods are very expensive like heavy seawall used for protection of the lighthouse in Niechorze and combined seawall in Rewal-Sliwin. They stopped erosion, but in front of the seawall in Niechorze there is almost no beach and strong link side effect. In front of combined seawall in Rewal-Sliwin there is very narrow beach and strong link side effect. Conservation both of them is very expensive.

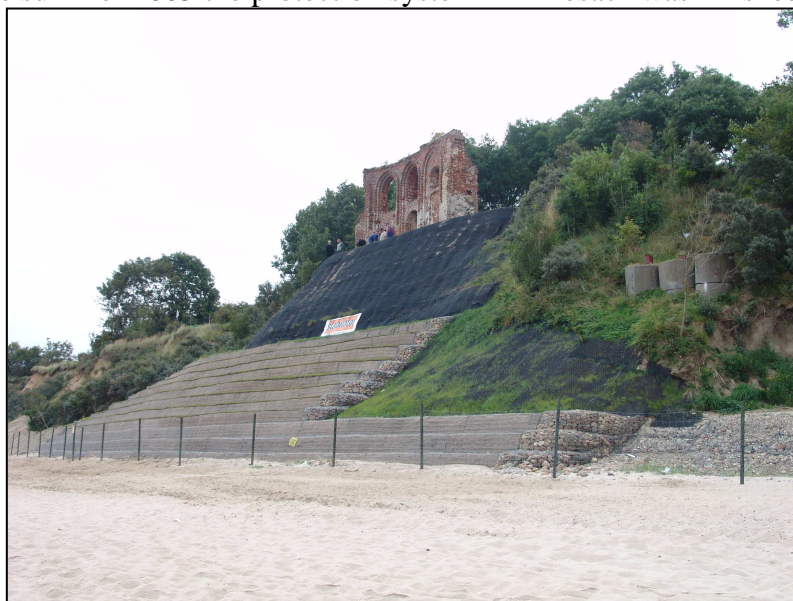
Fig. 7. Combined protection system in Trzesacz 2005. [Phot. J.Stodolny].

At present time a combined protection system was done. The ruins were connected with the cliff and the foot of the cliff was protected by 90 m long seawall made by gabions (sea photo at cover page and at Fig.7).

It consists of connecting the ruins with the scarp of the cliff and a seawall made by gabions at the foot of the cliff protecting the scarp of the cliff. A length of the seawall is about 90 m. The protected scarp of the cliff was covered by material suitable for vegetation.

This kind of protection will generate a “link side effect” in both sides of the seawall making erosion of the coast a bit faster.

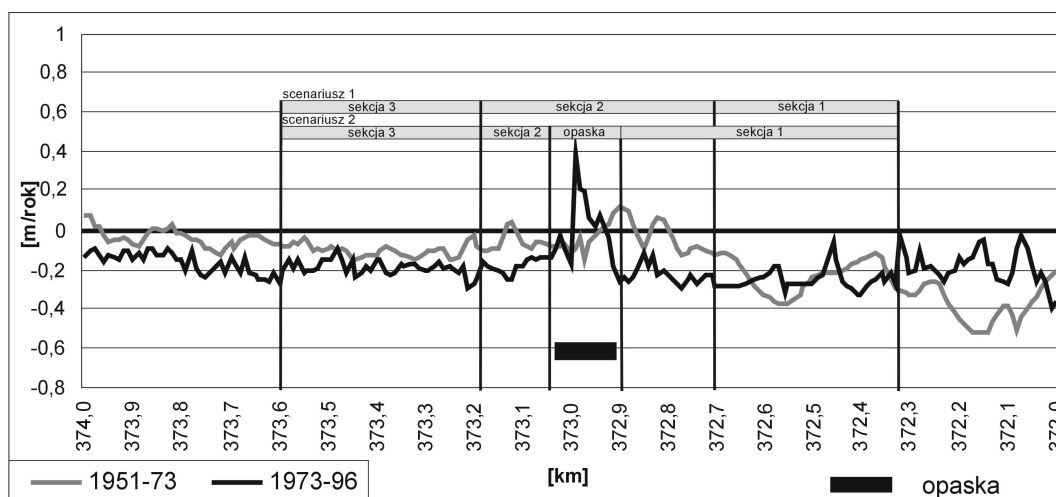
Fig. 10. Changes of cliff foot line in Trzesacz in years 1951-73 in 1973-96 [m].

To assign particular section of the coast and calculate tempo of changes the diagram of cliff foot line (fig.10.) position changes in period of time 1973-96 was analyzed. There were eliminated 4 sections of the coast with different rate of erosion. The length of these sections was: 405m, 115m [section protected by seawall], 100m and 300m.

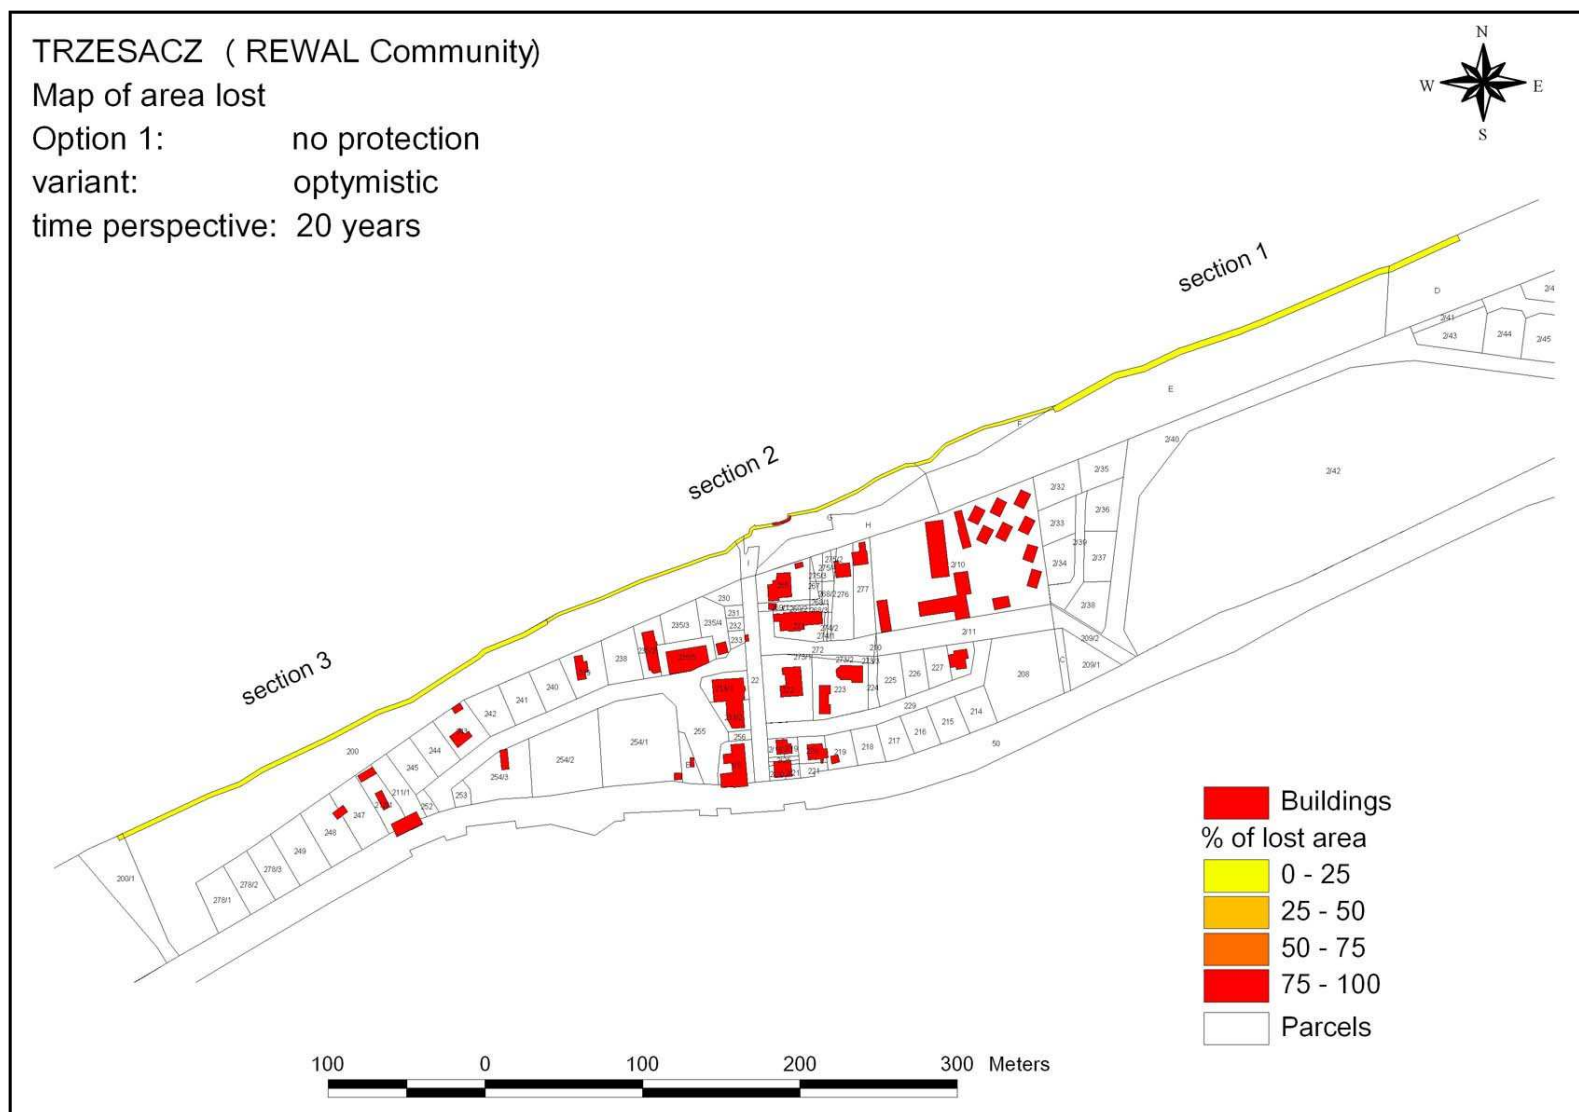
Map of area lost

variant: optimistic

time perspective: 20 years
