UNIVERSITY COLLEGE CORK
Coláiste na hOllscoile Corcaigh

Coastal & Marine Resources Centre
Ionad Acmhainní Cósta is Mara

Review of the Coastal Protection at Tramore Strand

FINAL REPORT

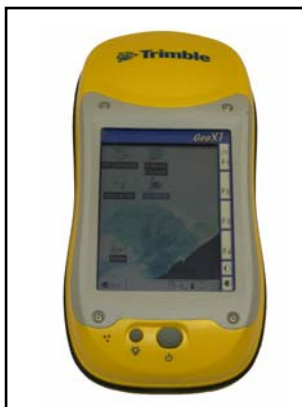
a Global Positioning System (GPS) was used to survey and fix the shoreline position for subsequent comparison with historical data. The GPS employed was a Trimble GeoExplorer CE (Figure 2.1) used in real-time and to give a positional accuracy (horizontal only) of $\pm 2\text{m}$.

Figure 2.1: Trimble GeoExplorer CE differential Global Positioning System

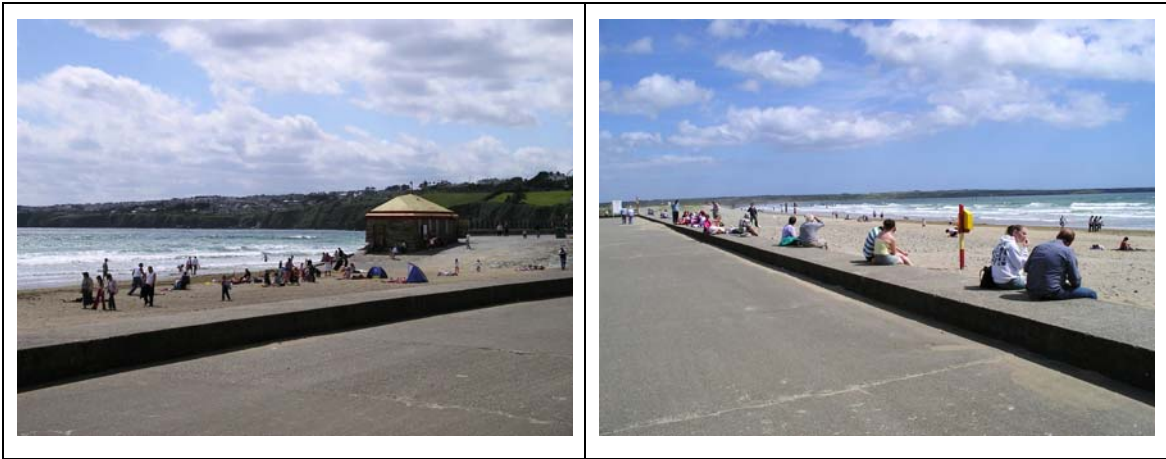
Figure 3.11: View Tramore promenade towards Great Newton Head (west)

Figure 3.12: View of Tramore promenade towards Brownstown Head (east)

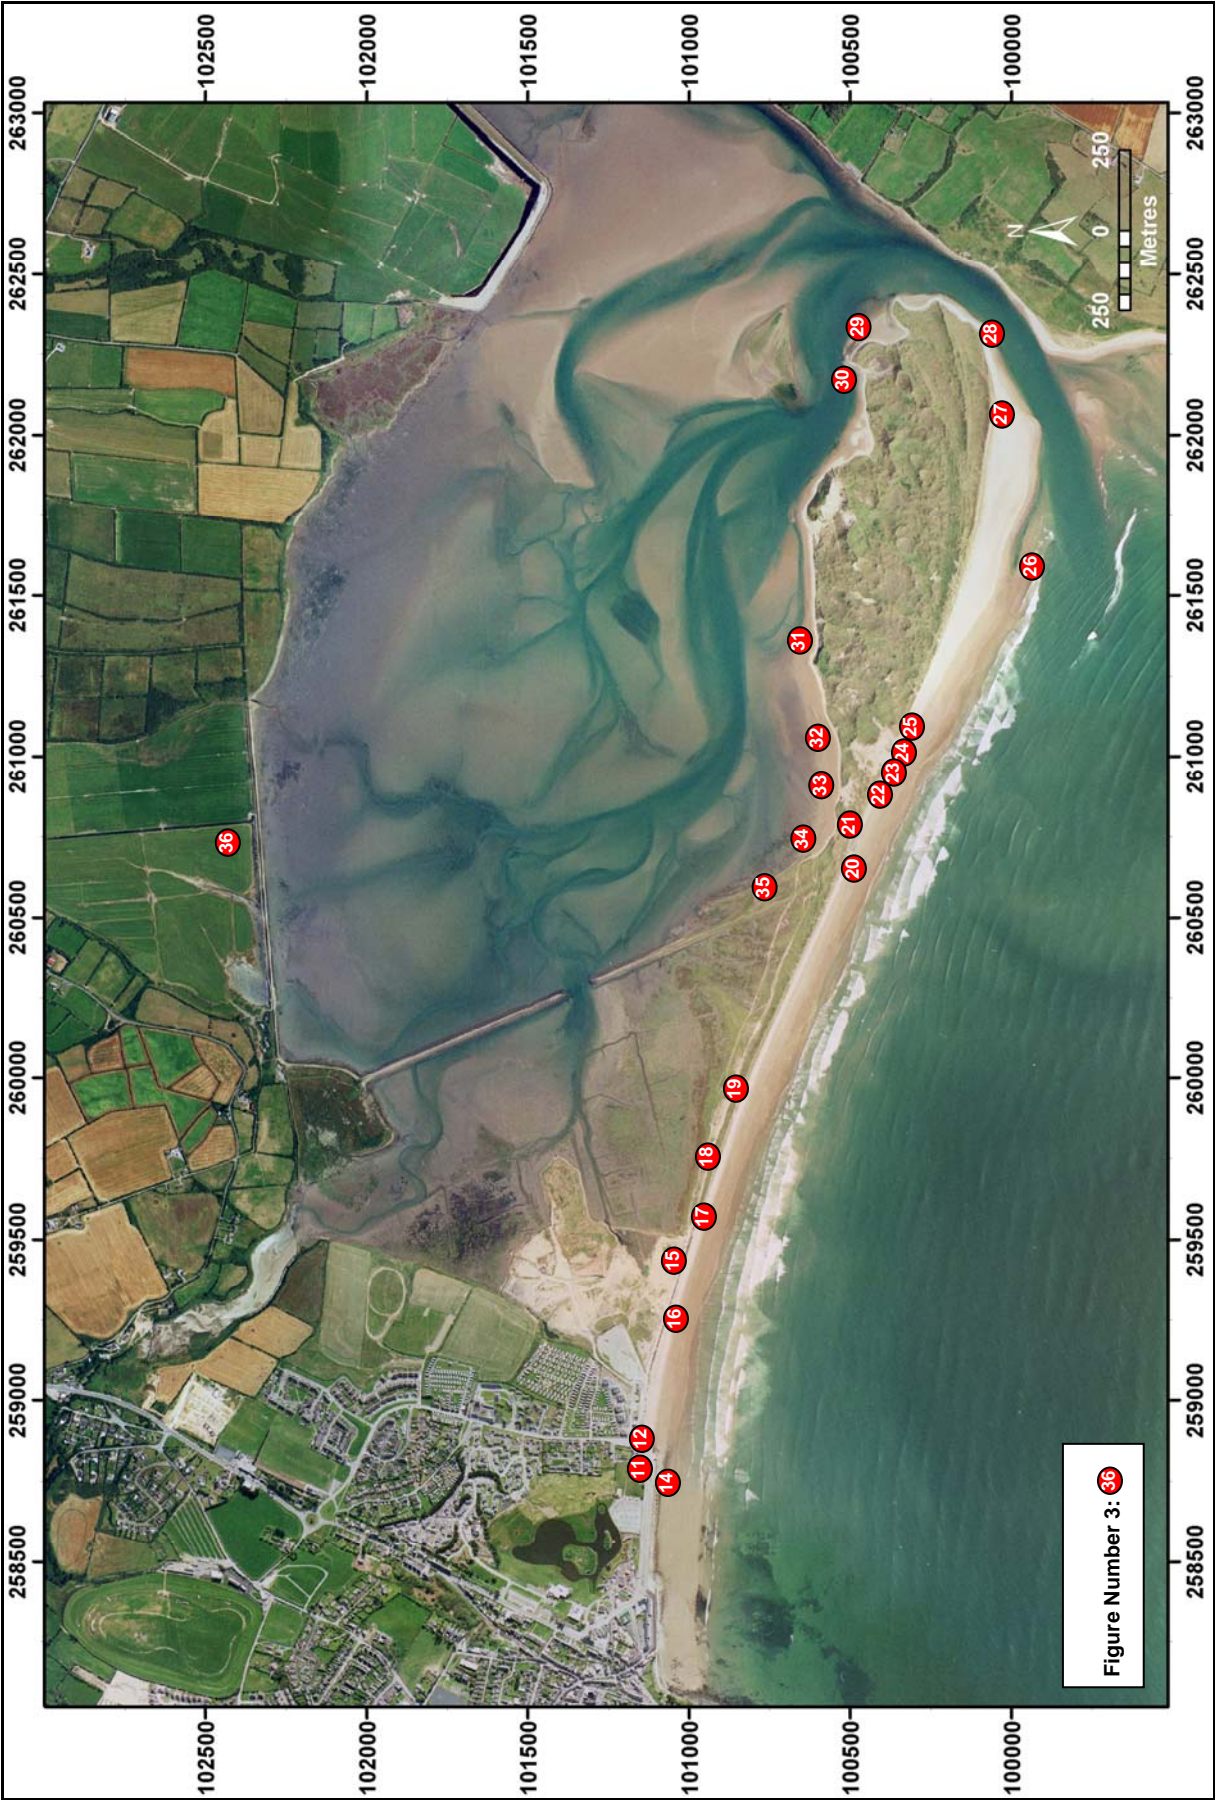
Figure 3.13: Aerial view of Tramore showing the subject of site visit photographs

The majority of site visits took place during the peak, summer season. The photographs taken during the site visits provided further evidence of the current use and condition of the coastline (an index of the photographs from site visits is provided in Figure 3.13). As suggested by the questionnaire survey, the largest proportion of users tended to confine their activities to the promenade and the adjacent beach (Figures 3.11/12). The majority of people in this area were availing of the local shops and amenities on the promenade or swimming, surfing and playing sports on the adjacent beach. As the coastline in this area is effectively fixed by the modern sea walls any user impact is limited to littering. Mechanical beach cleaning is conducted to alleviate this problem (Figure 3.14) and this obviously causes some disturbance to the natural sediment. However, as this is restricted to the summer season the overall impact would be expected to be minimal.

There is evidence of wear and tear from walkers along the top of the bank with tracks to the north clearly visible on the aerial photographs (Figure 3.13), which was re-confirmed on the ground, but the bank itself appeared to suffer little detrimental effects as a result of human activity. Of significantly greater impact in this area was the obvious impact of natural processes, wave and

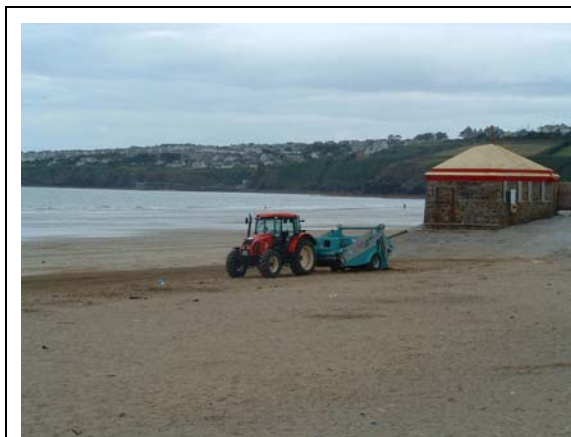
Figure 3.14: Mechanical beach cleaning on Tramore Strand

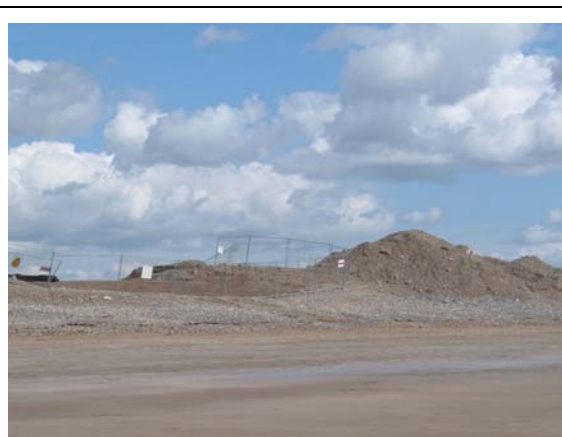
Figure 3.15: Impact on shingle bank during the water treatment plant construction at Tramore

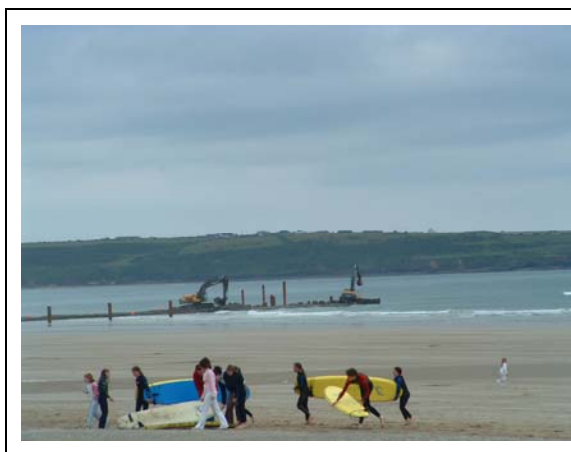
Figure 3.16: Surfers at Tramore with outflow pipeline construction in the background

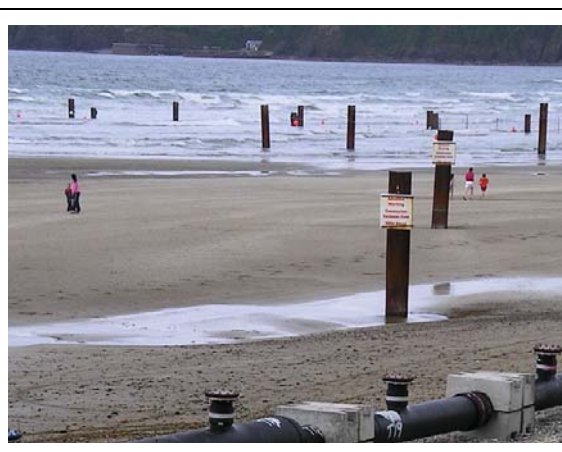
Figure 3.17: Walkers amidst construction materials at the site of the outflow pipeline Tramore

This beach and spit system is a local amenity and is heavily utilised by both local residents and a large number of tourists during key holiday periods. In recent years, Tramore has become a commuter town and the associated increase in population has further elevated the pressure on the natural resources on this section of coastline. The main concerns in the region include erosion, resulting from both natural processes and levels of usage, and waste management, especially issues surrounding the recently decommissioned landfill site. Previous water quality concerns appear to have been offset by the recently completed water treatment and drainage scheme (Figure 3.17/18).

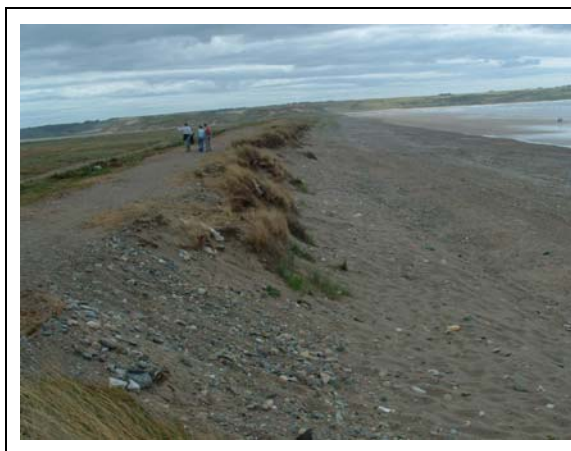
tides, (Figure 3.18) but it would appear that any major resultant damage is repaired by the County Council mechanically re-shaping the shingle bank (Figure 3.19).

Figure 3.18: Erosion on the face of the shingle bank at Tramore

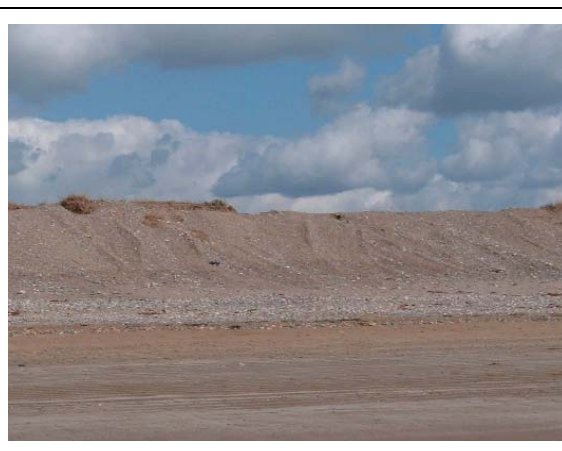
Figure 3.19: Tracks indicating mechanical reworking of shingle bank at Tramore

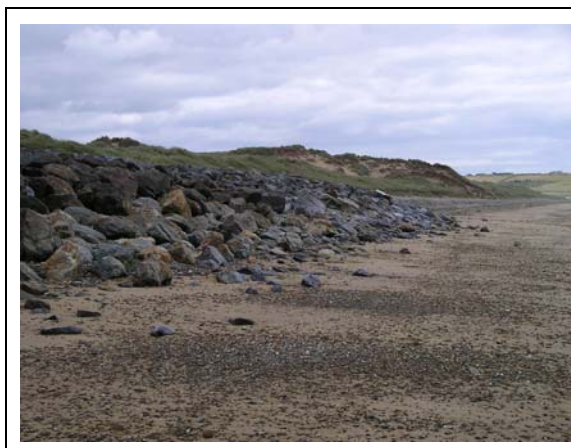
The neck of the spit is at its thinnest, c.55m, and has been obviously subjected to previous erosion. A typical sequence of events leading to erosion of the front face of dunes by marine processes is given as follows by Scottish Natural Heritage (2000):

Figure 3.20: Armour at the neck of the spit at Tramore Strand

In an attempt to protect against erosion, armouring has been positioned on the southern, beach side (Figure 3.20) and wooden fencing has been erected to the north, on the Back Strand (Figure 3.21/34). This location is probably the area of most concern as it is obviously been subjected to erosion on both aspects, north and south, and if there was a breach at this point it could lead to the spit feature becoming an island. In addition, this is the designated site of the medieval midden as

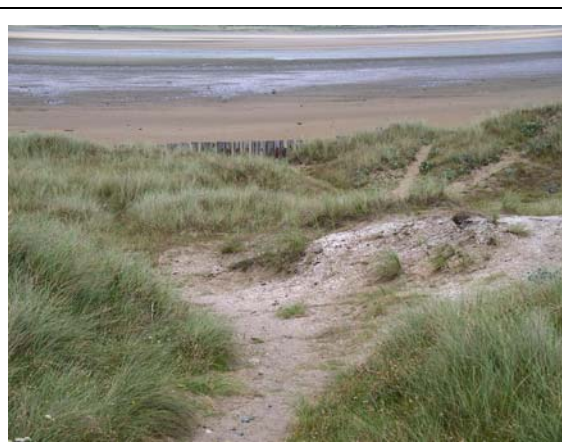
Figure 3.21: Site of the Midden in the dunes at Tramore

noted earlier (Figure 3.21) and from a heritage aspect there could be pressure to preserve this site from being lost to the sea.

In addition to the ecological interest at the site there are several Records of Monuments and Places (RMP) sites in the area (Figure 1.2). Of these, the most important would appear to be the Burrows at Tramore (circled in Figure 1.2 / Figure 3.21). This is detailed as a 'midden', and is stated as a kitchen midden of Neolithic age. According to McGrath (2001) two spreads of fire cracked stones in a black soil matrix and in an eroded state were also located on the Tramore Burrows. Such finds are considered to be important archaeologically because of the information about diet and animal husbandry that they can yield (McGrath, 2001).

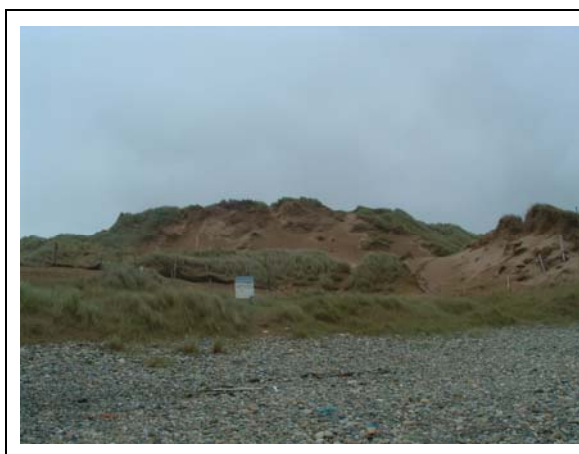
Further evidence of erosion was found to the east of the armoured section but this large blowout was primarily a result of scouring by the wind rather than the action of waves or tides (Figure 3.22). Blowouts are instigated by a breakdown of the fabric of the vegetation and exposure of the unconsolidated material underneath which is then simply blown away by the wind or washed away by overtopping tides and waves. The cause of this breakdown can be natural but other factors that contribute include impact by animals, large volumes of walkers, detrimental effects of quad or motorbike usage and open fires being lit in the dune system. All of these activities and other detrimental activities such as dune surfing were either recorded at Tramore during the site visits or highlighted by the questionnaire survey (Figure 3.4). Once exposed the dune system will struggle to recover if the uncontrolled use of the dunes continues and at this stage it may be necessary to provide some form of physical barrier to prevent further damage and promote recovery.

Figure 3.22: Dune blowout on Tramore Strand

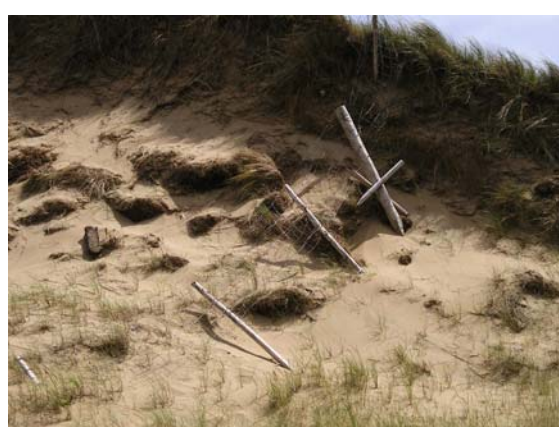
Figure 3.23: Damage to fencing around a blowout on Tramore Strand

There is evidence of a previous attempt to protect this area from the public by fencing off the blowout areas. Unfortunately, over time, the harsh environment appears to have severely damaged these protection measures to the extent that they now do not serve as any form of deterrent (Figure 3.23). The signage erected at the time had also been completely defaced (Figure 3.24) and therefore there is no way for users to determine the actual nature of the problem or the methodology that had been employed in an attempt to arrest it. Other methods can also be employed to assist natural consolidation of loose material and reverse the process. The experimental brushwood fencing (Figure 3.25) established by Waterford Institute of Technology appeared to be yielding positive results with new growth of Marram Grass, a primary coloniser, clearly evident.

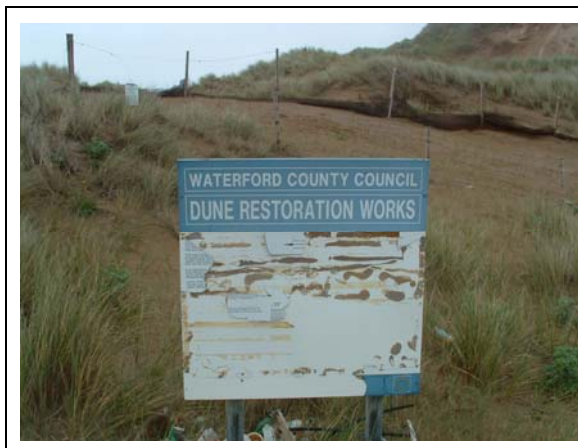
Figure 3.24: Weathering of signage at a restoration scheme at Tramore

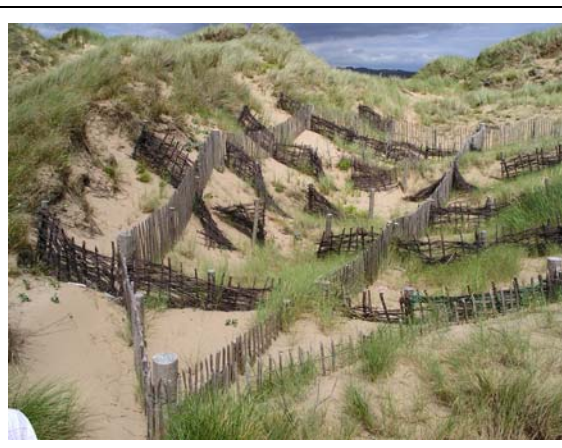
Figure 3.25: Remedial fencing in a blowout in the dunes at Tramore

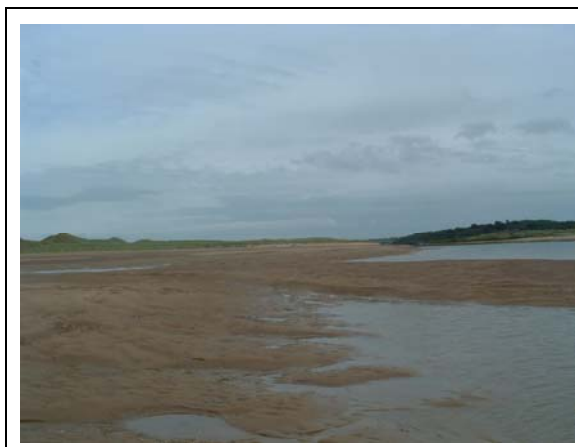
In contrast to the erosion at the neck and in the dune blowouts, there is currently very obvious accretion at the eastern extreme of the Strand at the tip of the spit (Figure 3.26). Loose re-worked sand and the forcing of the drainage channel towards Bass Point are testament to this process and the extent of this accretion and channel migration was clearly illustrated by the results of the GPS survey (Figure 3.39).

Figure 3.26: Accretion at the eastern extend of Tramore Strand

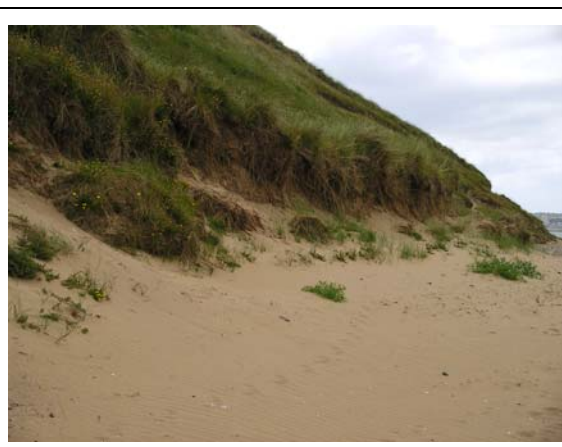
Figure 3.27: Evidence of previous slumping and recent re-growth at the eastern end of Tramore spit

Historical evidence of erosion in the form of slumping (Figure 3.27) was noted at the eastern end of the Strand parallel to the drainage channel but the more obvious trend here was also one of recent accretion. This accretion is supplemented by the presence of fresh plant growth suggesting that the dune system is being augmented at the point of the spit (Figure 3.28).

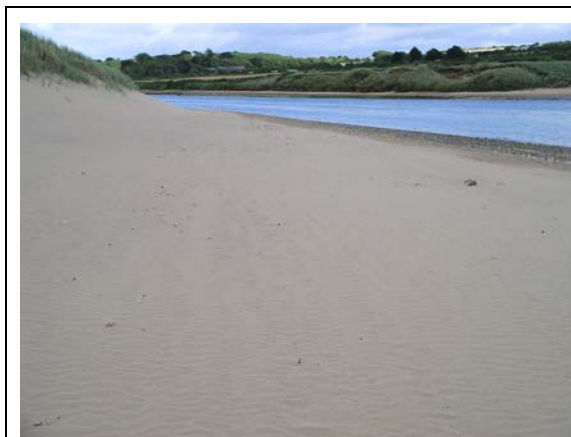
Figure 3.28: Accretion at the eastern end of Tramore Spit

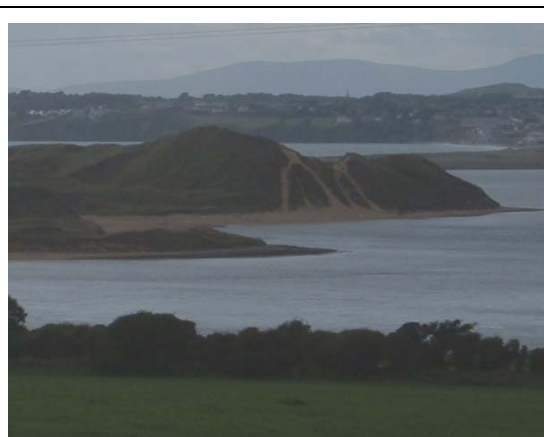
The highest dune in the complex is located approximately at the mid point of the Back Strand and from the marked tracks visible from a considerable distance, (Figure 3.29), it is clear that this has suffered damage. This was even more marked on the western flank of this dune where a massive blowout was encountered with the chances of recovery reduced by ongoing dune surfing (Figure 3.30).

Figure 3.29: Usage impact on dune system on the Back Strand at Tramore

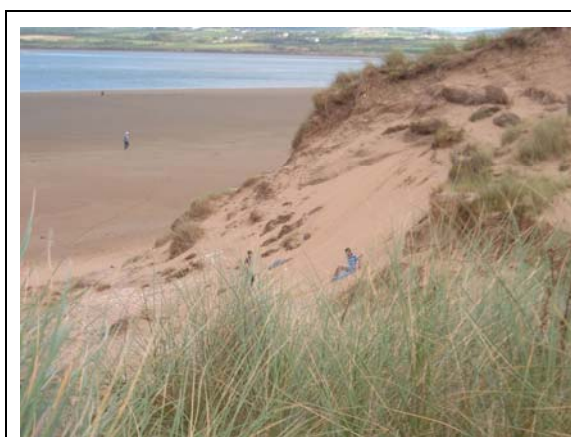
Figure 3.30: Dune surfing activity on the dunes at Tramore

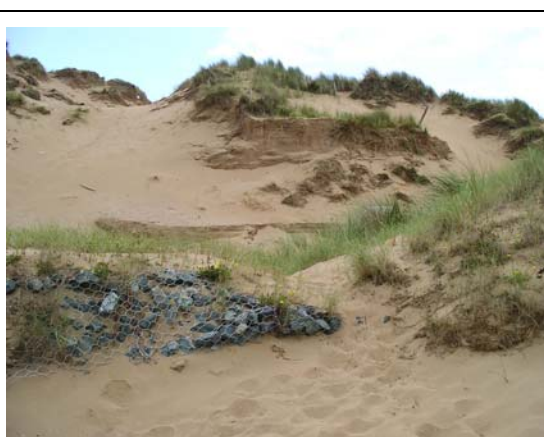
Figure 3.31: Exposed gabion on the dune complex on the Back Strand at Tramore

Erosion, both wind and sea driven, and the attempts to curb its effects were noted along the Back Strand (Figures 3.31/32/33). Whilst these attempts appeared to have some short-term success at stabilising the system they appeared to have suffered from a lack of maintenance and this had obviously impacted on their level of long term success (Figure 3.31). Signage in this area has also

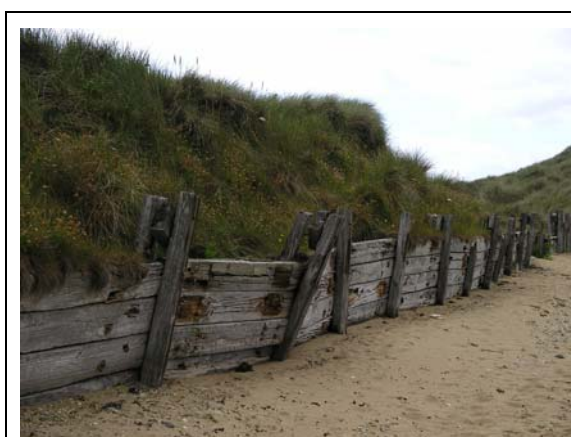
Figure 3.32: Protective fencing on the Back Strand at Tramore

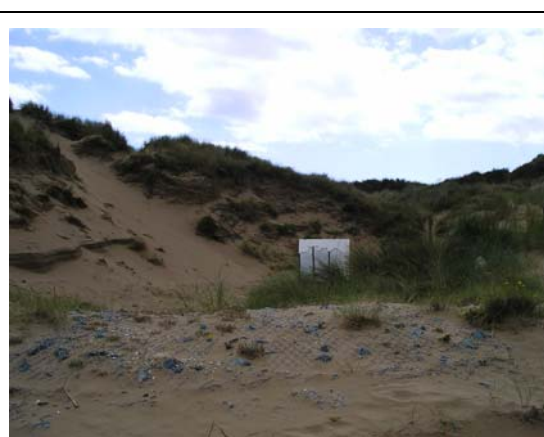
Figure 3.33: Exposed gabions and weathered signage on the Back Strand at Tramore

suffered as a result of the harsh conditions and therefore there was now no indication of either the problem or the solution attempted (Figure 3.33).

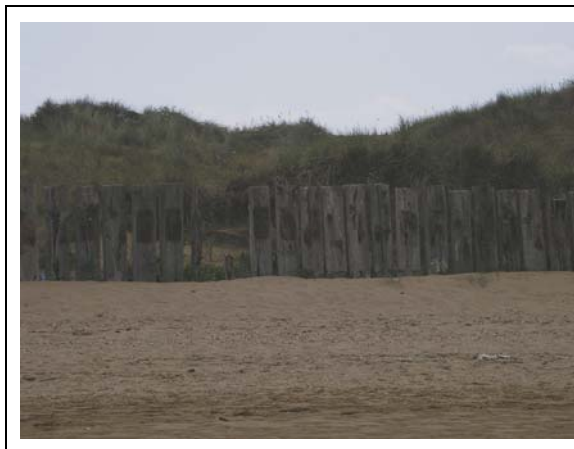
Figure 3.34: Protective fencing at the neck of the spit on the Back Strand at Tramore

At the inner edge at the neck of the spit there was further evidence of protection from natural processes (Figure 3.34) but given that this is a natural shortcut back to the beach there was no protection from the potential threat posed by walkers tramping across this area. A further indication of detrimental use of the dune system was revealed by the damage caused by open fires in the area immediately adjacent and to the west of the neck (Figure 3.35).

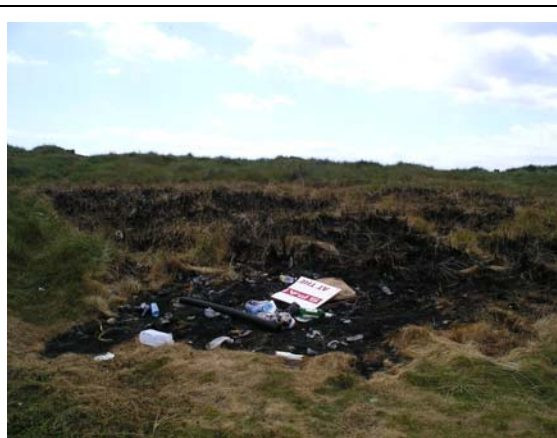
Figure 3.35: Evidence of a recent open fire at the western end of the Back Strand

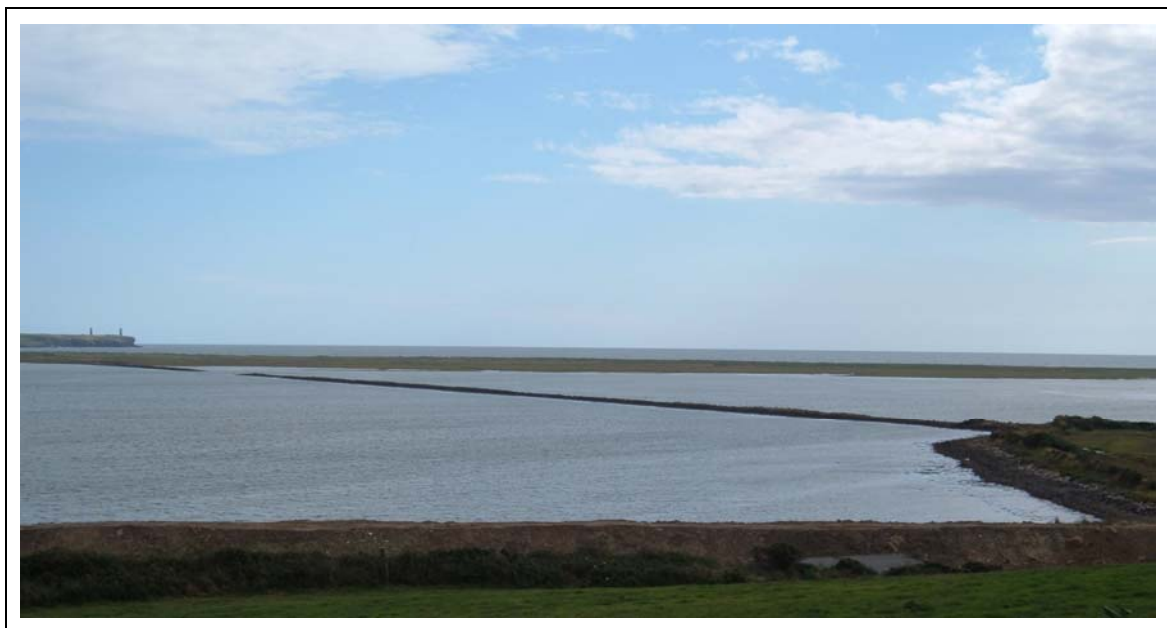
At the western extreme of the Back Strand the intertidal area is extended by the historical breach of Malcomson's Bank which allows the tide to enter at high water (Figure 3.36).

Figure 3.36: View of the defences on the northern edge of the inner bay and the breach in Malcomson's Embankment at highwater at Tramore

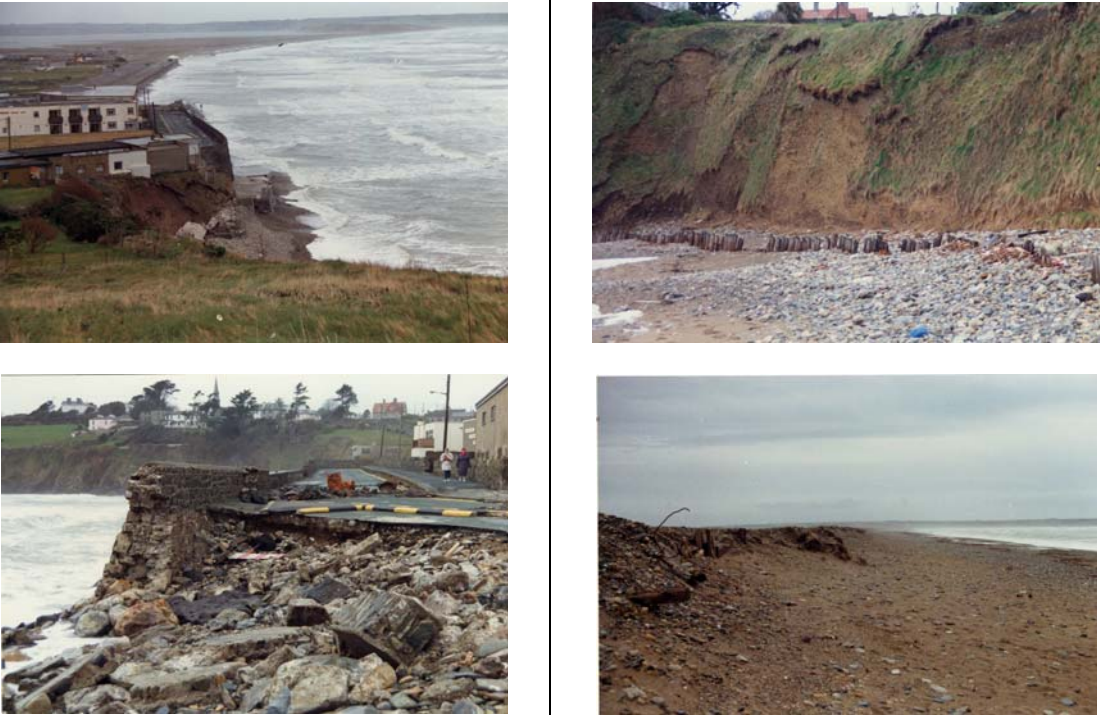
Figure 3.37: Examples of storm damage at Tramore in 1989 (Punch 1990)									
1990	<p>Following the severe storm on the night of December 16th 1989, the coast of Tramore was badly damaged (Figure 3.37)</p> <p>Remedial works included:</p>

<table><tr> <td>Reconstruction of sea wall</td><td>£73,831.23</td></tr><tr> <td>Repairs to rubble masonry wall</td><td>£18,201.83</td></tr><tr> <td>Repairs to slipway</td><td>£30,163.58</td></tr></table>
