Assessment of a Gravel Nourishment Project Fronting a Seawall at Marina di Pisa, Italy

Cammelli C.†, Jackson N.L.‡, Nordstrom K.F.§ and Pranzini E.†

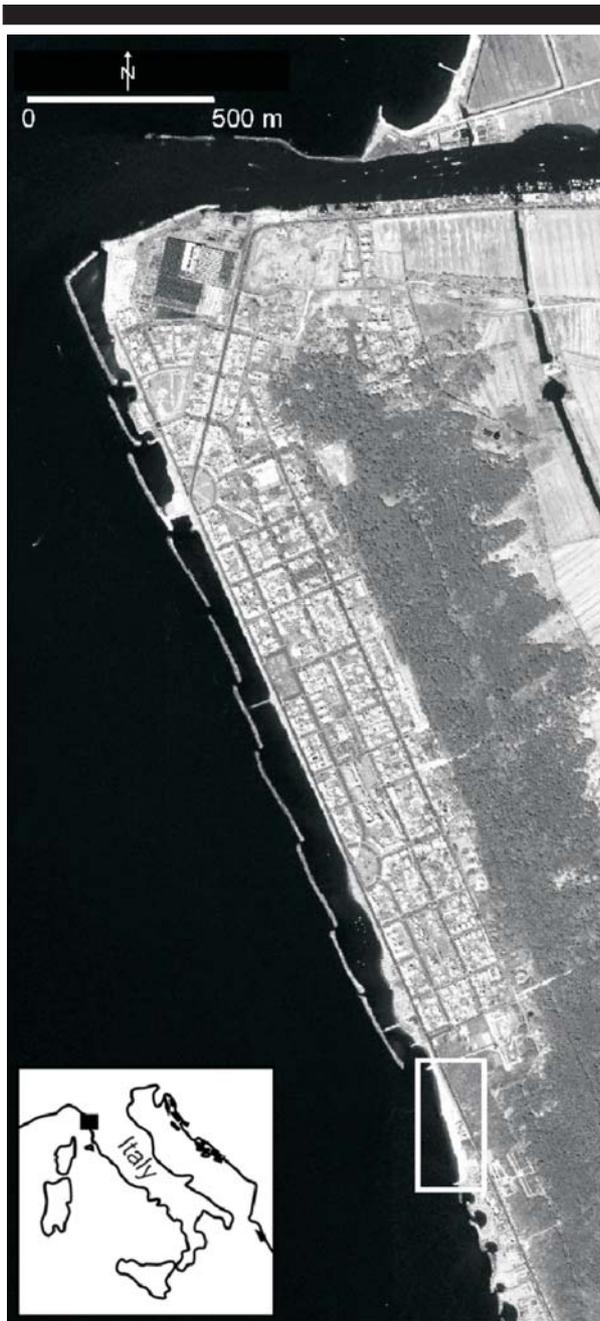
Figure 1. Study area.

portion of gravel beach in front of the 330 m long seawall downdrift of the breakwaters (Figure 1). This experiment provides a unique opportunity to study the morphological adjustment of gravel fill placed on a sandy shore to see if the reduction in wave reflectance helps transport sand onshore and see whether an unprotected gravel beach is stable in this coastal sector. Previous studies have identified the advantages of using gravel as fill material or as a dynamic revetment because it has greater stability than sand (EVERTS *et al.* 2002; US ARMY CORPS OF ENGINEERS 2002; KOMAR *et al.* 2003). Our study identifies some of the problems and advantages of using gravel as fill where it does not occur naturally.

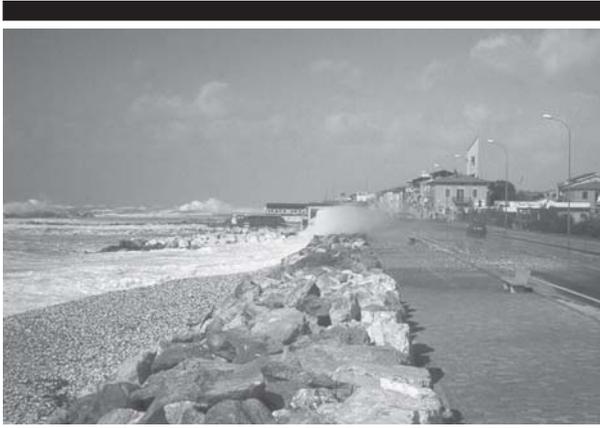
Figure 7. Waves breaking over seawall during the high-intensity storm occurring 6 October 2003.

after reshaping by earth moving equipment. The elevation of the berm crest is higher than the seawall in places (Profile C, Figure 5), reaching 4 m above msl. Where the berm is narrower, the crest intercepts the seawall at the same top elevation, and some clasts are transported over the seawall and onto the street during storms (Figure 7). Where the available material is sufficient to develop a backshore (Profile B, Figure 5), the storm crest is far from the seawall and this problem does not occur. Traffic was prevented from passing the study areas twice in a year on average prior to the project because of waves passing over the seawall. After deposit of fill traffic was not prevented, even during the severe storm of 4-5 October 2003 (Figure 7).
